**Flood Control Project Maintenance  
Levee Inspections**  
**LMA District Cover Sheet**  
**Spring 2020 Levee Inspection Results**

**Reclamation District No. 1001 Nicolaus**

**Spring 2020 Levee Inspection Results**

**Levee Inspection Report By Mile - Spring 2020**

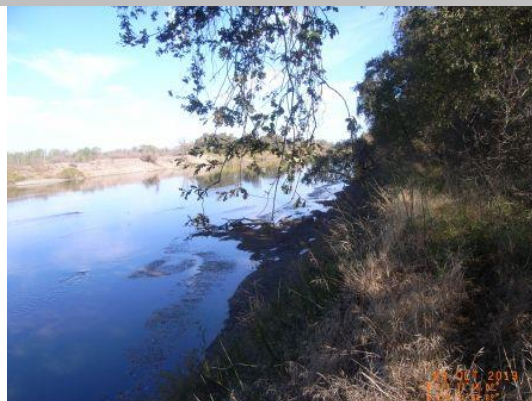
Photo 1 of 1 : SP\_2020\_RD1001\_38\_18\_20200227\_00007.jpg

LM Start	6.42	Rating **	A/W	Issue No.	18
LM End	6.51	Issue Type +	Ma	Location *	WS
Category	Supplemental			GPS Latitude/Longitude	
				Start	End
Item	2017 USACE Erosion Survey			38.865875 °	38.864706 °
				-121.619983 °	-121.620813 °
DWR ID	DWR_RD1001_04_f_2018_18				
Comment Code					
Inspector Comment					
2017 Site ID: FHR 6.0 L					
Status: Critical					
2017 Field Notes: Upgraded to critical, entire bank slope is slumping, with near vertical face					
Site History: 2011 - Tall slumping sections. Scour around trees has exposed most of the roots. 2016 - Recent large slope failure observed.

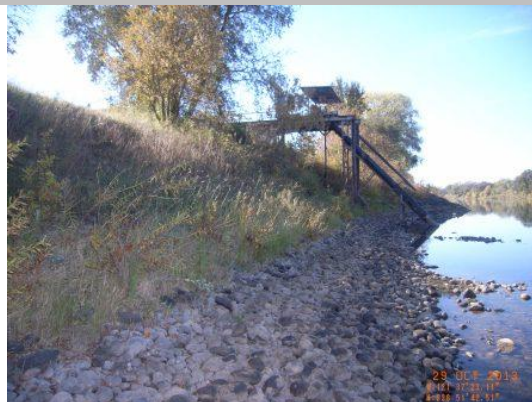
Photo 1 of 1 : SP\_2020\_RD1001\_38\_15\_20200227\_00005.jpg

LM Start	6.57	Rating **	A/W	Issue No.	15
LM End	6.77	Issue Type +	Ma	Location *	WS
Category	Supplemental			GPS Latitude/Longitude	
				Start	End
Item	2017 USACE Erosion Survey			38.863946 °	38.861558 °
				-121.621388 °	-121.623316 °
DWR ID	DWR_RD1001_04_f_2018_15				
Comment Code					
Inspector Comment					
2017 Site ID: FHR 5.8 L					
Status: Eroding					
2017 Field Notes: slope is not stable enough to maintain vegetation growth, new erosion					
Site History: 2011 - Large slumped sections on the lower bank. 2012 - New cracks observed.

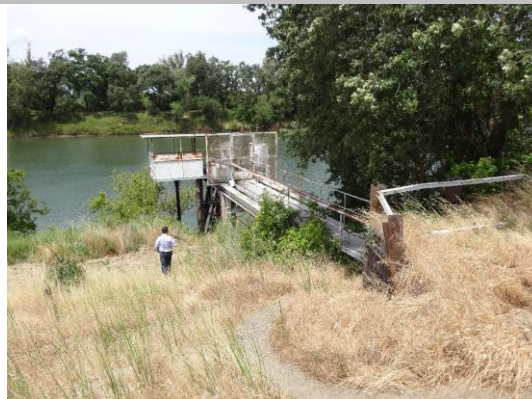
Photo 1 of 3 : UCIP\_SP\_2020\_55172\_24060.jpg

DS\_ID:22587  
FS\_ID:55172  
EP\_NO: 3903  
Repair Type: Urgent  
Crossing Status: Found  
UCIP Comments: 08/21/2019 Crossing has been updated from No Action Needed to Urgent, leaky pipe visible on LS. Open cut on LS visible from LS shoulder. Owner is coordinating with CVFPB on emergency repair. Pipe has failed and is no longer in use. Refer to CVFPB Enf ID 15536 for further coordination details. (O. Magana - DWR UCIP)08/14/2019 Pipe is under enforcement action and pipe is expected to be replaced under emergency repair. Contact Alex Acosta with CVFPB for updates. (O. Magana - DWR UCIP)  
05/16/2013 - working during field survey- found steel standpipe instead of concrete standpipe.- siphon breaker on the waterward side not found. (P. Amatya - DWR UCIP)  
FIELD\_STRUCT\_DESC: 20-inch welded steel irrigation discharge pipe through the levee, 8.2 feet below the crown. 16-inch propeller pump and platform on the riverbank. Pressure breakers on the landside (LS) corrugated metal pipe (CMP) riser. Pipe discharges into a steel standpipe in the LS toe. (20-inch steel irrigation discharge pipe and 16-inch propeller pump authorized under Permit No. 3903, 1962 - White Oak Ranch).

WS- pump station on steel structure on river bank.

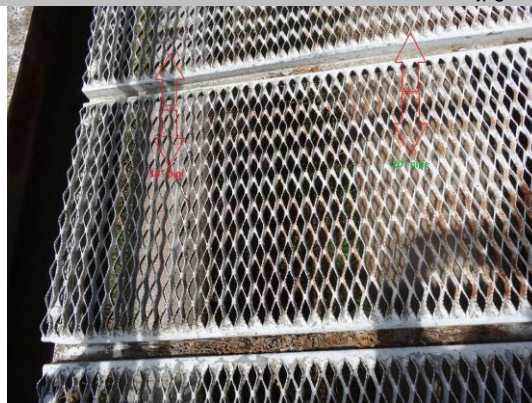
Photo 3 of 3 : UCIP\_SP\_2020\_55173\_24068.jpg

DS\_ID:22586  
FS\_ID:55173  
EP\_NO: 2062  
Repair Type: Urgent  
Crossing Status: Found  
UCIP Comments: 09/16/2019 Crossing has been updated from No Action Needed to Urgent, leaky pipe found. Record has been updated to reflect authorizing permit for the existing 14-inch pipe and new 14-inch vertical propeller pump. Pipe and pump were authorized under Permit Number 1388 in 1949, see page 12 of 12 which shows correct historic levee mile noted as "2-28-62 Now Marked Unit 4 - 6.87". (O. Magana - DWR UCIP)08/21/2019 Pipe is being addressed under CVFPB Enforcement ID 15536. Pipe appears to be leaking near the WS crown hinge point as water is beginning to penetrate. Pipe was running during inspection. (O. Magana - DWR UCIP)08/14/2019 Permit No. 2062 was incorrectly referenced per CVFPB - Alex Acosta. The correct pipe associated with Permit No. 2062 is dsid 22589. This pipe (dsid 22586) does not have a permit currently assigned to it. Pipe is under enforcement action and pipe is expected to be replaced under emergency repair. 14-inch pipe is referenced in Permit No. 3903 records. (O. Magana - DWR UCIP)

WS- steel pipes visible through steel walkway.

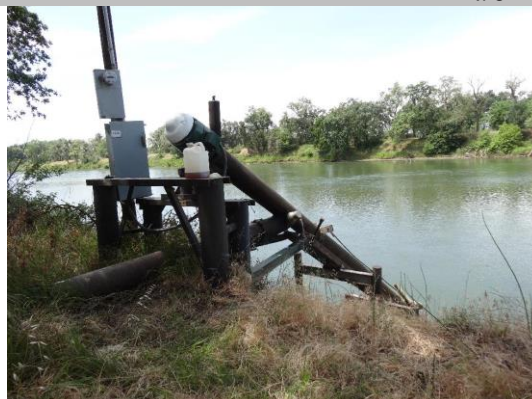
Photo 1 of 3 : UCIP\_SP\_2020\_55174\_24041.jpg

WS- slanted pump station, pipe, power pole on river bank.

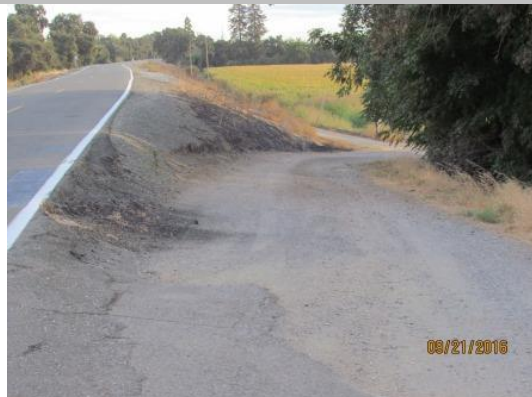
Photo 1 of 1 : SP\_2020\_RD1001\_38\_36\_20200227\_00020.jpg

LM Start	7.60	Rating **	A/W	Issue No.	36
LM End	7.60	Issue Type +	Ma	Location *	LS
Category	Earthen Levee			GPS Latitude/Longitude	
				Start	End
Item	Crown Surface / Depressions / Rutting			38.850521 °	38.850521 °
				-121.629423 °	-121.629423 °
DWR ID	DWR_RD1001_04_f _ 2015_36				
Comment Code					
C2 : Repair depressions or ruts in the crown or slope.					
Inspector Comment					
Ramp has vertical cut into the levee prism.

View of vertical cut for ramp in the landside levee slope looking upstream.

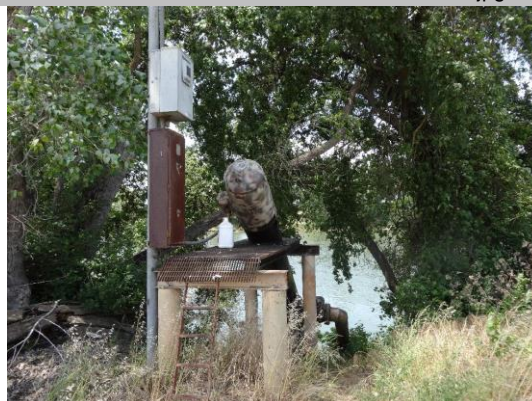
Photo 1 of 3 : UCIP\_SP\_2020\_55175\_24033.jpg

Comment Code					
Inspector Comment					
DS_ID:22576 FS_ID:55175 EP_NO: 2931 Repair Type: Urgent Crossing Status: Found UCIP Comments: 08/21/2019 Record has been updated from No Action Needed to Urgent due to an unauthorized cut on the WS. Unauthorized open cut visible on WS berm. CMP riser located on the LS toe has been replaced. Need to contact owner to determine if CVFPB has been contacted for the open cut and concrete work proposed on WS berm. DWR Levee Inspector, S. York, has been notified of the issue. (O. Magana - DWR UCIP)05/16/2013 - working during field survey- pipe expose on LS. (P. Amatya - DWR UCIP) FIELD_STRUCT_DESC: 18-inch steel irrigation discharge pipe through the levee, 4.9 feet below the crown. 18-inch, 50-horsepower slant pump mounted on a steel structure on the riverbank. Siphon breaker in a 6-inch steel riser on the landside (LS) shoulder. Pipe discharges into a 36-inch corrugated metal pipe (CMP) riser on the LS slope. (18-inch, 50-horsepower slant pump and irrigation discharge pipe authorized under Permit No. 2931, 1958 - Aileen Marty). [Additional Reference(s): DWR Levee Log, 1993]. FS Date: 8/21/2019 1:08:00 PM

WS- slanted pump station with steel structure, and service pole on river bank.

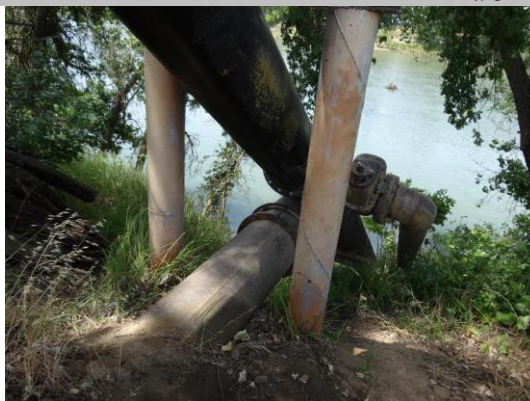
Photo 2 of 3 : UCIP\_SP\_2020\_55175\_24032.jpg

WS- inlet steel pipe and main steel pipe in pump station on river bank.

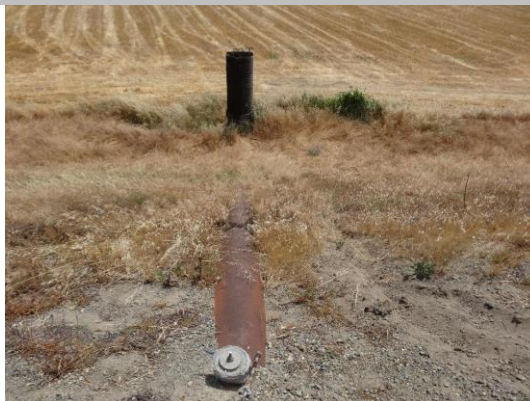
Photo 3 of 3 : UCIP\_SP\_2020\_55175\_24031.jpg

LM Start	<b>7.92</b>	Rating **	U	Issue No.	<b>94 (cont)</b>
LM End	<b>7.92</b>	Issue Type +	En	Location *

LS- siphon breaker, exposed steel pipe, and CM standpipe on landside.

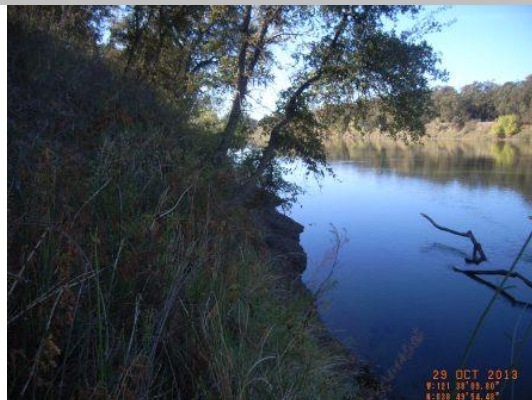
Photo 1 of 1 : SP\_2020\_RD1001\_38\_13\_20200227\_00003.jpg

LM Start	8.59	Rating **	A/W	Issue No.	13
LM End	9.47	Issue Type +	Ma	Location *	WS
Category	Supplemental			GPS Latitude/Longitude	
				Start	End
Item	2017 USACE Erosion Survey			38.836601 °	38.824642 °
				-121.633701 °	-121.639534 °
DWR ID	DWR_RD1001_04_f_2018_13				
Comment Code					
Inspector Comment					
2017 Site ID: FHR 3.8 L					
Status: Eroding					
2017 Field Notes: New erosion along lower slope					
Site History: 2006 - Sandy, silty bank with intermittent pockets of erosion. Rotational failure and tree pop outs are most of the problem. Some upper slope fluvial erosion. 2010 - Site extended upstream. The lower Feather may benefit from a regional repair. 2011 - Site combined with 3.6. Minimal new erosion. 2013 - New erosion observed at bank toe. Trees on site now have exposed roots.

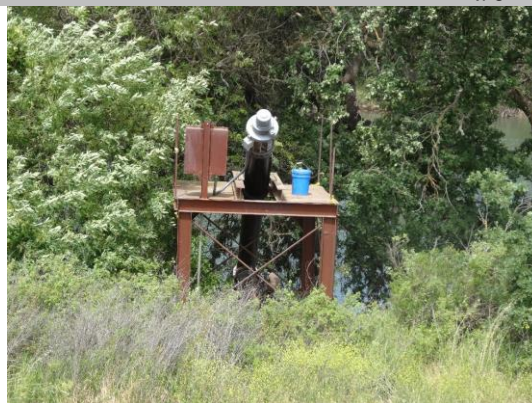
Photo 1 of 3 : UCIP\_SP\_2020\_55177\_24002.jpg

Comment Code						
Inspector Comment						
DS_ID:22577 FS_ID:55177 EP_NO: 12828 Repair Type: Non-Urgent Crossing Status: Found UCIP Comments: 08/21/2019 Record remains Non-Urgent, unable to complete a thorough inspection of this levee section. Dense vegetation at both the WS slope/berm and LS toe prevented a thorough inspection of this crossing. (O. Magana - DWR UCIP)05/16/2013 - needs detailed investigation for road surface cracks (P. Amatya - DWR UCIP) FIELD_STRUCT_DESC: 16-inch asphalt coated steel irrigation discharge pipe through the levee, 4.3 feet below the crown. 30-horsepower slant pump and platform on the riverbank. (16-inch irrigation discharge pipe and 30-horsepower slant pump authorized under Permit No. 12828, 1979. It is assumed that this 16-inch pipe replaces the abandoned 10-inch steel pipe referenced in the O&M Manual). [Additional Reference(s): DWR Levee Log, 1993. USACE Sacramento O&M Manual 141.1, August 1955, (RM 3.3), abandoned 10-inch steel pipe referenced]. FS Date: 8/21/2019 1:08:00 PM

WS- slanted pipe in steel structure on river bank.

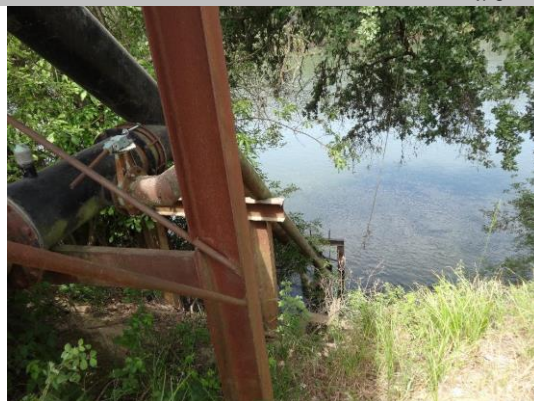
Photo 2 of 3 : UCIP\_SP\_2020\_55177\_24001.jpg

WS- inlet pipe and main pipe in pump station on river bank.

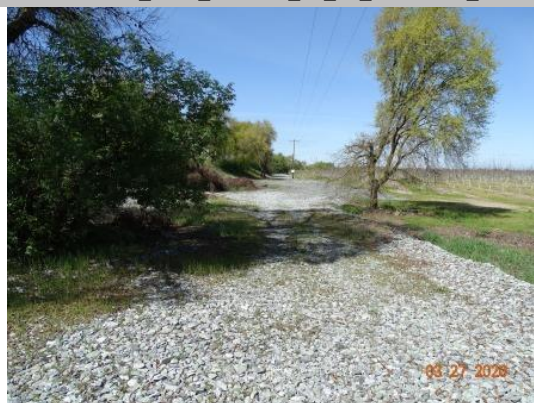
Photo 1 of 1 : SP\_2020\_RD1001\_38\_43\_20200407\_00074.jpg

LM Start	9.43	Rating **	A/W	Issue No.	43
LM End	9.43	Issue Type +	Ob	Location *	LS
Category	Earthen Levee			GPS Latitude/Longitude	
				Start	End
Item	Seepage / Sandboils			38.825234 °	38.825234 °
				-121.639279 °	-121.639279 °
DWR ID	247-2				
Comment Code					
Inspector Comment					
This was a 2017 Storm Damage Site.					
Site ID No:163					
Site Designation:247-2

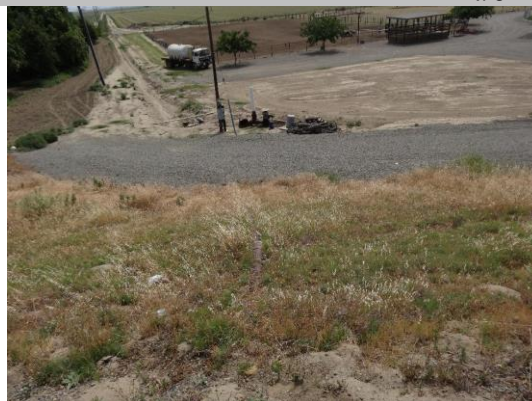
Photo 3 of 3 : UCIP\_SP\_2020\_55178\_23964.jpg

Comment Code						
Inspector Comment						
DS_ID:22592 FS_ID:55178 EP_NO: N/A Repair Type: Non-Urgent Crossing Status: Found UCIP Comments: 08/21/2019 Record remains Non-Urgent, pipe has been abandoned through the levee. Pipe was only visible on LS. No signs of pipe or appurtenances were visible from the river. Recommend geophysical study to determine if pipe is still present through the levee. Owner will need to coordinate with the CVFPB to remove or abandon pipe according to Title 23 requirements. (O. Magana - DWR UCIP)05/16/2013 - seems abandoned pipe crossing.- needs properly abandoned.- a 48" steel tank not found on landside. (P. Amatya - DWR UCIP) FIELD_STRUCT_DESC: 12-inch steel irrigation discharge pipe through the levee, 5 feet below the crown. Pump on the riverbank. Pipe discharges into a 48-inch steel tank at the landside (LS) toe. (Johnston). [Additional Reference(s): DWR Levee Log, 1993. USACE Sacramento O&M Manual 141.1, August 1955, (RM 3.1)]. FS Date: 8/21/2019 1:09:00 PM

LS- overview of landside, steel pipe on levee slope.

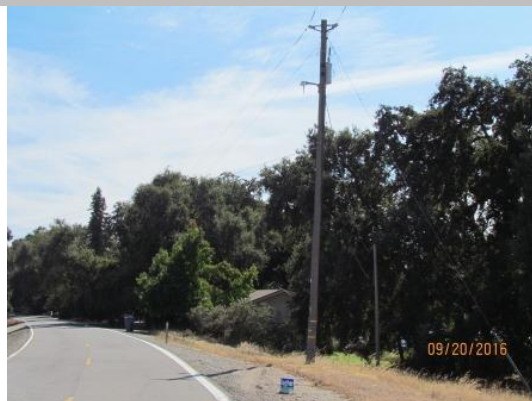
Photo 1 of 1 : SP\_2020\_RD1001\_38\_80\_20200227\_00027.jpg

LM Start	9.52	Rating **	M	Issue No.	80
LM End	9.52	Issue Type +	En	Location *	WS
Category	Earthen Levee			GPS Latitude/Longitude	
				Start	End
Item	Encroachments			38.823911 °	38.823911 °
				-121.639869 °	-121.639869 °
DWR ID	DWR_RD1001_04_s_2016_80				
Comment Code					
PO : Pole					
Inspector Comment					
Power pole on waterside levee crown.

View of unpermitted power pole on waterside crown.

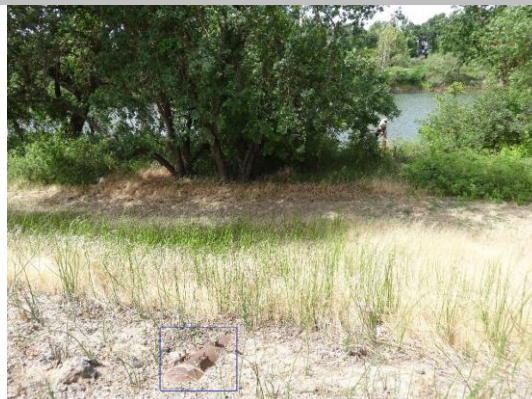
Photo 1 of 3 : UCIP\_SP\_2020\_55179\_24134.jpg

DS\_ID:22578  
FS\_ID:55179  
EP\_NO: 3297  
Repair Type: Non-Urgent  
Crossing Status: Found  
UCIP Comments: 08/21/2019 Record remains Non-Urgent, pipe appears abandoned. Siphon breaker has been damage without repair since 2013. If crossing is abandoned the owner will need to coordinate with the CVFPB to properly remove/abandon pipe per Title 23. (O. Magana - DWR UCIP)05/16/2013 - needs properly abandoned.- dismantled standpipe found on LS levee slope (P. Amatya - DWR UCIP)  
FIELD\_STRUCT\_DESC: 12-inch steel irrigation discharge pipe through the levee, 3 feet below the crown. Slant pump mounted on a steel structure on the riverbank. Siphon breaker on the landside (LS) shoulder. Pipe discharges into a 24-inch concrete standpipe at the LS toe. (12-inch pipe and pump authorized under Permit No. 3297, 1960 - Albert Linggi). [Additional Reference(s): DWR Levee Log, 1993].  
FS Date: 8/21/2019 1:09:00 PM

WS- exposed pipe on levee slope and pump station in river bank.

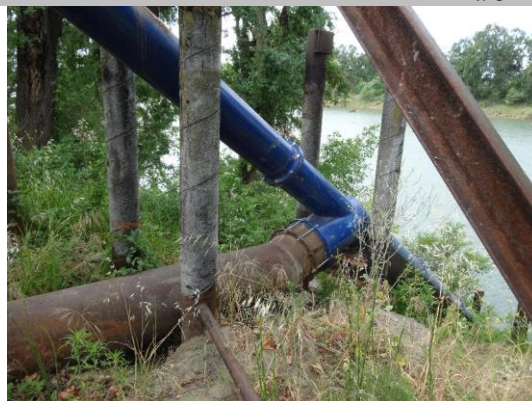
Photo 2 of 3 : UCIP\_SP\_2020\_55180\_23976.jpg

WS- main steel pipe on levee surface (without paint).

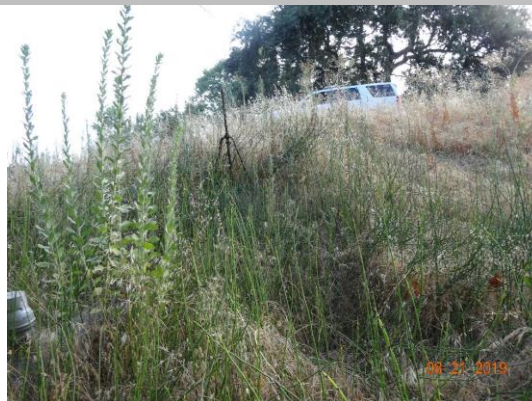
Photo 3 of 3 : UCIP\_SP\_2020\_55180\_81186.jpg

WS view: limited visibility to evaluate pipe crossing through levee section.

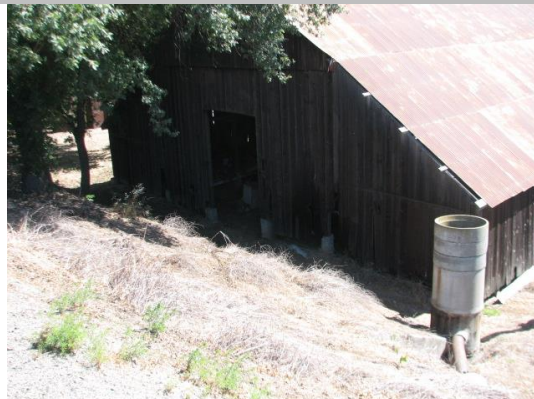
Photo 1 of 1 : SP\_2020\_RD1001\_38\_29\_20200227\_00013.jpg

LM Start	10.60	Rating **	M	Issue No.	29
LM End	10.60	Issue Type +	En	Location *	LS
Category	Earthen Levee			GPS Latitude/Longitude	
				Start	End
Item	Encroachments			38.809256 °	38.809256 °
				-121.633908 °	-121.633908 °
DWR ID	DWR_RD1001_04_s_2013_29				
Comment Code					
BU : Building					
Inspector Comment

The building is within the easement of the levee.

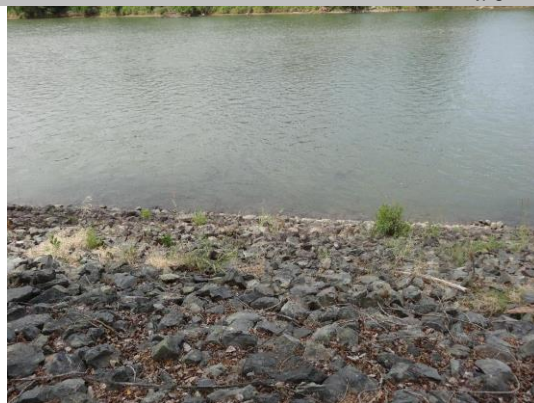
Photo 1 of 3 : UCIP\_SP\_2020\_55181\_23974.jpg

Comment Code						
Inspector Comment						
DS_ID:22579 FS_ID:55181 EP_NO: N/A Repair Type: Non-Urgent Crossing Status: Found UCIP Comments: 08/21/2019 Record has been updated from No Action Needed to Non-Urgent, pipe has been abandoned through the levee. Pipe is abandoned with only pipe section found on LS. No signs of pipe were visible from the river. (O. Magana - DWR UCIP)05/16/2013 - Only a portion of the pipe found on landside. (P. Amatya - DWR UCIP) FIELD_STRUCT_DESC: *ABANDONED* 8-inch pipe of an unknown material or purpose through the levee, 7.7 feet below the crown. Capped on the waterside (WS) end in 1955. (Rutz). [Additional Reference(s): DWR Levee Log, 1993]. FS Date: 8/21/2019 1:10:00 PM

WS- no pipe or structure found.

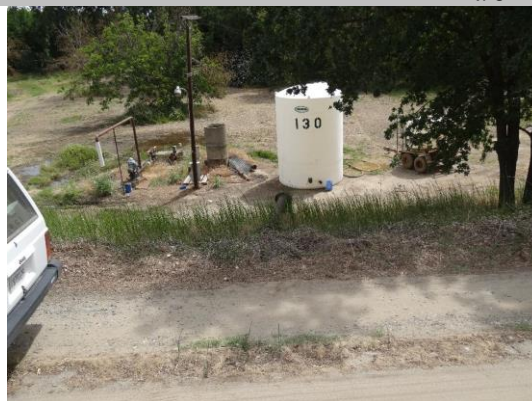
Photo 2 of 3 : UCIP\_SP\_2020\_55181\_23973.jpg

LS- overview of landside of the levee.

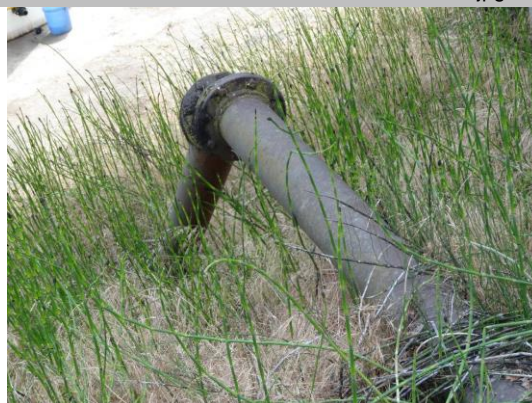
Photo 3 of 3 : UCIP\_SP\_2020\_55181\_23975.jpg

LS- portion of steel pipe exposed in levee slope.

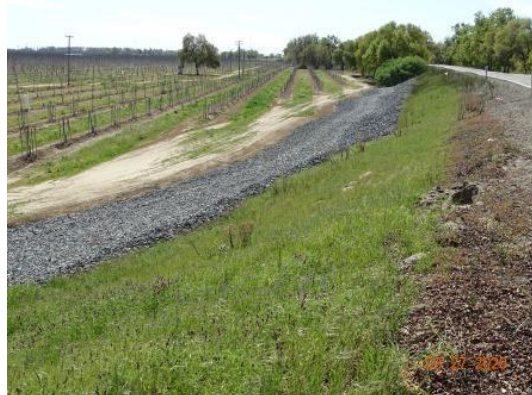
Photo 1 of 1 : SP\_2020\_RD1001\_38\_61\_20200407\_00080.jpg

LM Start	11.12	Rating **	A/W	Issue No.	61
LM End	11.24	Issue Type +	Ob	Location *	LS
Category	Earthen Levee			GPS Latitude/Longitude	
				Start	End
Item	Seepage / Sandboils			38.801876 °	38.800202 °
				-121.632684 °	-121.632222 °
DWR ID	DWR_RD1001_04_s _ 2020_61				
Comment Code					
Inspector Comment					
This was a 2017 Storm Damage Site. Temporarily repaired by DWR during 2017 flood fight. Permanent repairs are required through entire reach. Estimated cost for all sites repaired, \$14.6 million					
Site ID No:491					
Site Designation:LMA-329

View looking upstream landside of the seepage berm emergency repair done in 2017.

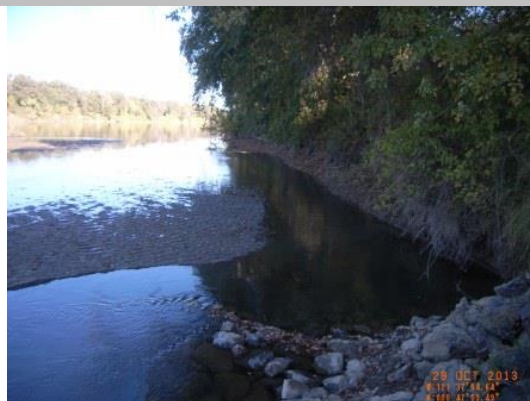
Photo 1 of 1 : SP\_2020\_RD1001\_38\_10\_20200227\_00002.jpg

LM Start	11.18	Rating **	A/W	Issue No.	10
LM End	11.37	Issue Type +	Ma	Location *	WS
Category	Supplemental			GPS Latitude/Longitude	
				Start	End
Item	2017 USACE Erosion Survey			38.800920 °	38.798165 °
				-121.633050 °	-121.631939 °
DWR ID	DWR_RD1001_04_f_2018_10				
Comment Code					
Inspector Comment					
2017 Site ID: FHR 1.0 L					
Status: Eroding					
2017 Field Notes: Significant new erosion along lower bank.					
Site History: 2000 - Site is relatively stable except for some toe erosion at the upstream end, recommend monitoring the upstream end. 2004 - Some new block failures (10ft deep) at the toe of the upstream end. 2007 - Some minor new slumping at the waterline. 2013 - Minor new erosion along the bank toe.

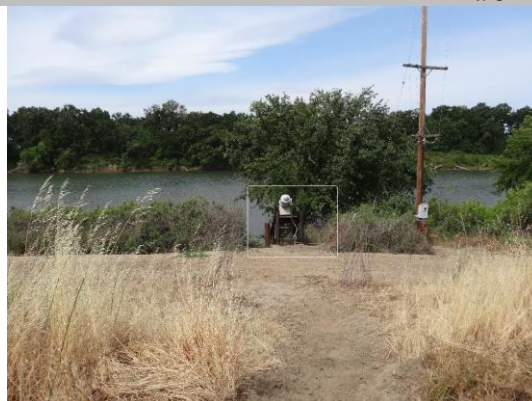
Photo 1 of 3 : UCIP\_SP\_2020\_55966\_23970.jpg

DS\_ID:22580  
FS\_ID:55966  
EP\_NO: 3489-1  
Repair Type: Non-Urgent  
Crossing Status: Found  
UCIP Comments: 08/21/2019 Record remains Non-Urgent, maintenance work for this crossing is still pending. New pipe section was added to WS from intake to where pipe daylights. Work is almost complete. Updated photos of the construction work have been forwarded to DWR Levee Inspector for Permit records. (O. Magana - DWR UCIP)05/16/2013 - siphon breaker on the landward shoulder not found.- cracked road surface along the pipe alignment. Needs more investigations. (P. Amatya - DWR UCIP)  
FIELD\_STRUCT\_DESC: 16-inch irrigation discharge pipe of an unknown material through the levee, 3 feet below the crown. 40-horsepower slant pump mounted on a steel structure on the riverbank. Pipe discharges into a 36-inch concrete standpipe at the landside (LS) toe. (16-inch pipe and 40-horsepower pump authorized under Permit No. 3489, 1960 - Kirtland Brothers; name change authorized under Permit No. 3489-1, 2018 - Global AG Properties USA LLC c/o WGIM, Inc.) [Additional Reference(s): DWR Levee Log, 1993].

WS- slant pump on river bank.

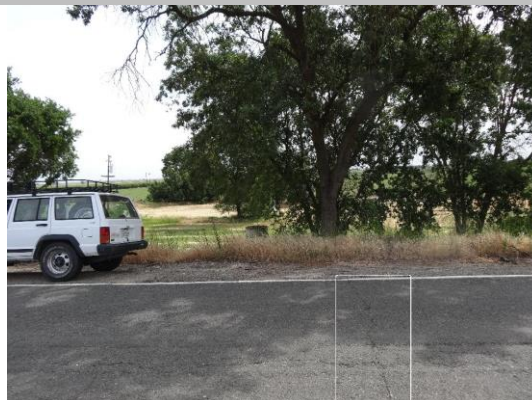
Photo 2 of 3 : UCIP\_SP\_2020\_55966\_23969.jpg

Levee Crown- surface crack along pipe crossing. Needs more investigation.

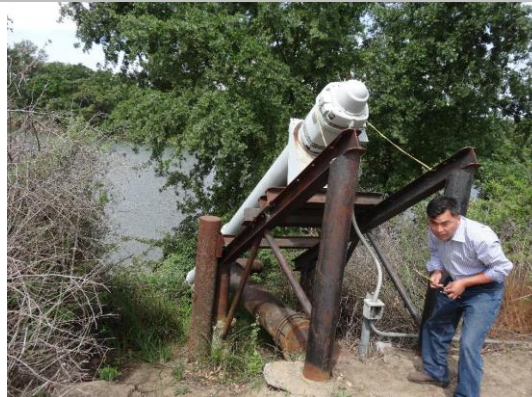
Photo 3 of 3 : UCIP\_SP\_2020\_55966\_23968.jpg

WS- slant pump, pipe on steel piles.

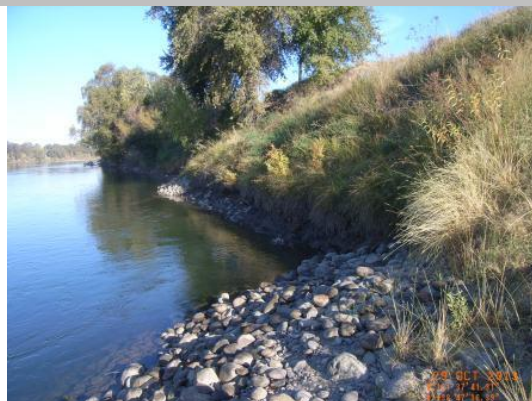
Photo 1 of 1 : SP\_2020\_RD1001\_38\_9\_20200227\_00001.jpg

LM Start	11.59	Rating **	A/W	Issue No.	9
LM End	11.75	Issue Type +	Ma	Location *	WS
Category	Supplemental			GPS Latitude/Longitude	
				Start	End
Item	2017 USACE Erosion Survey			38.795455 °	38.793394 °
				-121.629903 °	-121.628156 °
DWR ID	DWR_RD1001_04_f_2018_9				
Comment Code					
Inspector Comment					
2017 Site ID: FHR 0.6 L					
Status: Eroding					
2017 Field Notes: Further toe erosion, with sections of sand deposition.					
Site History: 1997- Deposits over top of cobble on the upper slope.					
2000 - Old cobble site in poor shape; some toe retreat, but little change; steep bank. 2010 - Site extended upstream due to new toe erosion.					
2012 - Minor new erosion at toe, new slumping, animals holes and cracks observed.

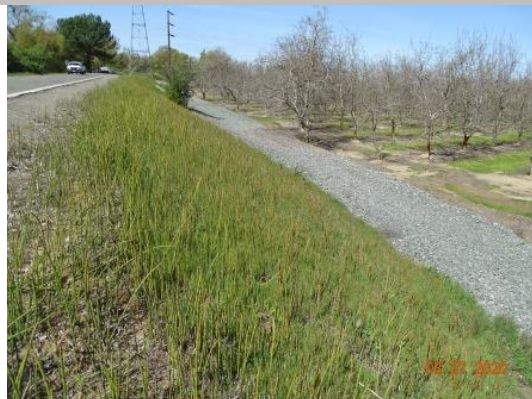
Photo 1 of 1 : SP\_2020\_RD1001\_38\_63\_20200407\_00075.jpg

LM Start	12.61	Rating **	A/W	Issue No.	63
LM End	12.80	Issue Type +	Ob	Location *	LS
Category	Earthen Levee			GPS Latitude/Longitude	
				Start	End
Item	Seepage / Sandboils			38.784976 °	38.783967 °
				-121.616723 °	-121.613386 °
DWR ID	DWR_RD1001_04_s_2020_63				
Comment Code					
Inspector Comment					
This site was temporarily repaired by DWR during 2017 flood fight. Permanent repairs are required through entire reach. Estimated cost for all sites repaired, \$14.6 million. Site ID No:491 Site Designation:LMA-329

View looking upstream landside of the seepage berm emergency repair done in 2017.

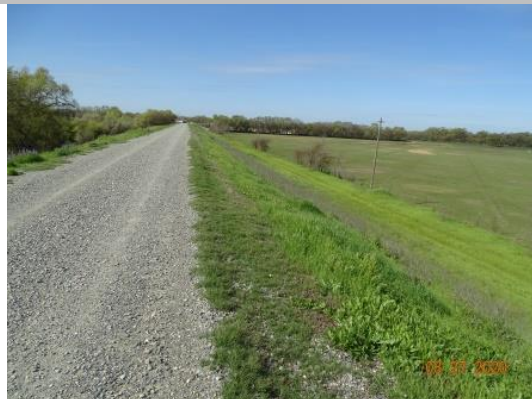
Photo 1 of 1 : SP\_2020\_RD1001\_39\_11\_20200406\_00021.jpg

LM Start	0.00	Rating **	A	Issue No.	11
LM End	5.39	Issue Type +	Ma	Location *	LS
Category	Earthen Levee			GPS Latitude/Longitude	
				Start	End
Item	Vegetation			38.781246 °	38.831097 °
				-121.605437 °	-121.529738 °
DWR ID	DWR_RD1001_05_s_2020_11				
Comment Code					
V1 : Control annual grass and weeds on the levee slopes and easements.					
Inspector Comment					
The annual vegetation is well maintained, Spring 2020.

View looking downstream landside at the well maintained annual vegetation, Spring 2020.

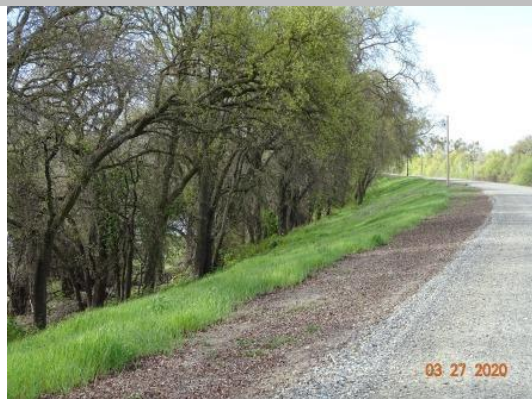
Photo 1 of 1 : SP\_2020\_RD1001\_39\_12\_20200406\_00023.jpg

LM Start	0.00	Rating **	A	Issue No.	12
LM End	5.39	Issue Type +	Ma	Location *	WS
Category	Earthen Levee			GPS Latitude/Longitude	
				Start	End
Item	Vegetation			38.781246 °	38.831097 °
				-121.605436 °	-121.529738 °
DWR ID	DWR_RD1001_05_s_2020_12				
Comment Code					
V1 : Control annual grass and weeds on the levee slopes and easements.					
Inspector Comment					
The annual vegetation is well maintained, Spring 2020.

View looking downstream waterside at the well maintained annual vegetation, Spring 2020.

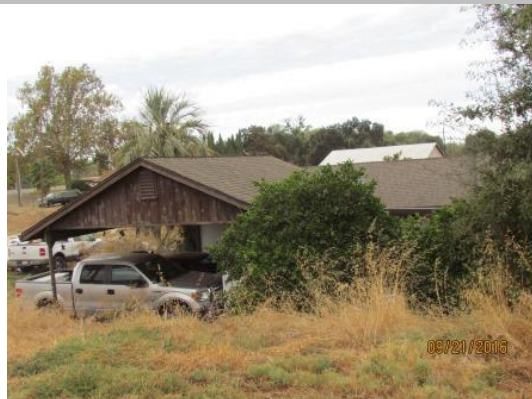
Photo 1 of 1 : SP\_2020\_RD1001\_39\_13\_20200227\_00006.jpg

LM Start	0.05	Rating **	M	Issue No.	13
LM End	0.05	Issue Type +	En	Location *	LS
Category	Earthen Levee			GPS Latitude/Longitude	
				Start	End
Item	Encroachments			38.781881 °	38.781881 °
				-121.605215 °	-121.605215 °
DWR ID	DWR_RD1001_05_f_2016_13				
Comment Code					
BU : Building					
Inspector Comment					
House and carport are at landside levee toe.

View of a house and carport that are at the levee toe.

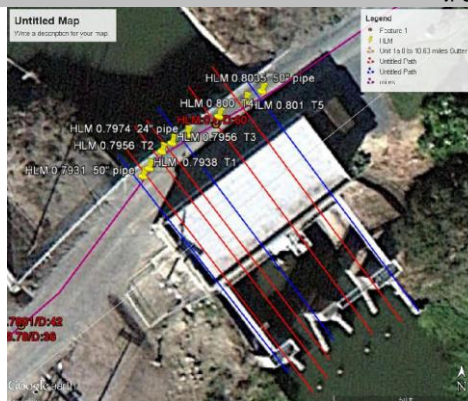
Photo 1 of 3 : UCIP\_SP\_2020\_14393\_23697.jpg

DS\_ID:22610  
FS\_ID:14393  
EP\_NO: N/A  
Repair Type: Non-Urgent  
Crossing Status: Found  
UCIP Comments: 08/22/2019 Record has been updated with USACE O&M reference. (O. Magana - DWR UCIP)  
05/15/2013 - needs repair of concrete piers on waterside. Rebar exposed from the pier. Even though this pier is functionally not linked to the pipe, it needs repair. (P. Amatya - DWR UCIP)  
FIELD\_STRUCT\_DESC: [RD 1001 Drainage Pumping Plant] 5 of 8: 24-inch reinforced concrete drainage discharge pipe through the levee, 25 feet below the crown. Five 60-inch by 84-inch reinforced concrete drainage tunnels through the levee, 25 feet below the crown. One tunnel has a 60-inch pump installed inside and is gated on the waterside (WS) end. Two 50-inch steel drainage discharge pipes through the levee, 25 feet below the crown. All tunnels and pipes are gated. Concrete headwall and railing along the landside (LS). (Reclamation District No. 1001). [Additional Reference(s): DWR Levee Log, 1993. USACE Sacramento O&M Manual, Unit 142 Back Levee of Reclamation District No. 1001, June 1959, Revised 04 May 2018, five 4-foot by 5-foot culverts, two 50-inch pipe, and one 20-inch pipe (HLM 0.80)].

Location of pipes and tunnels. 24-inch steel pipe located at 5th from the left.

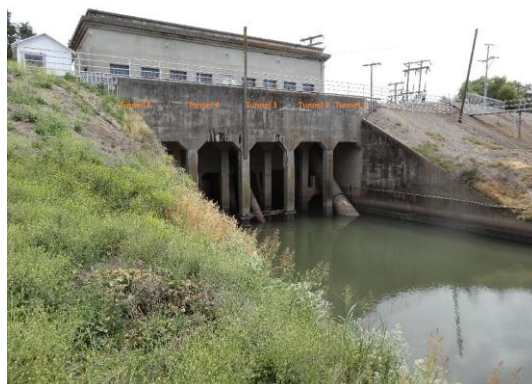
Photo 2 of 3 : UCIP\_SP\_2020\_14393\_23696.jpg

LS- Drainage structure with tunnels, pipes and pump house. Tunnel 1 at far right and tunnel 5 at far left. The pipe is located inside tunnel 3.

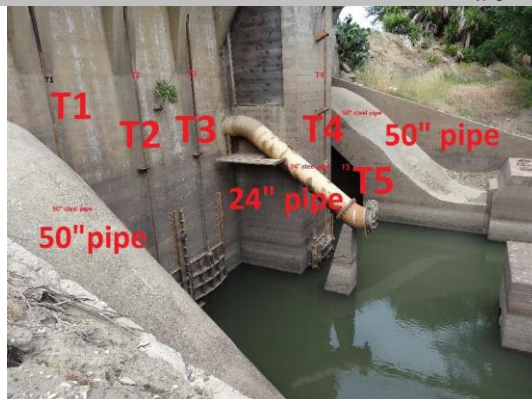
Photo 3 of 3 : UCIP\_SP\_2020\_14393\_23799.jpg

WS- three steel pipes inside tunnel. Fifty inch pipes on left and right. Twenty four inch pipe in middle of the structure as shown.

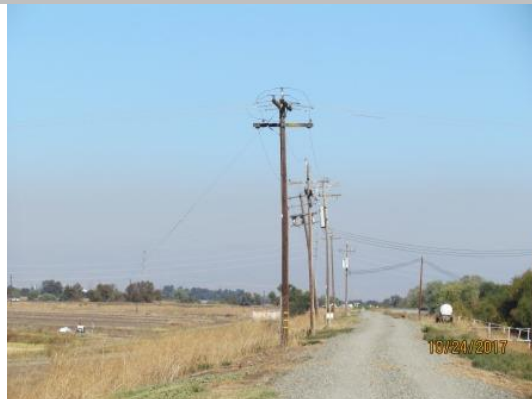
Photo 1 of 1 : SP\_2020\_RD1001\_39\_7\_20200227\_00001.jpg

LM Start	3.56	Rating **	M	Issue No.	7
LM End	3.81	Issue Type +	En	Location *	LS
Category	Earthen Levee			GPS Latitude/Longitude	
				Start	End
Item	Encroachments			38.814919 °	38.817178 °
				-121.556712 °	-121.552965 °
DWR ID	DWR_RD1001_05_s_2012_7				
Comment Code					
PO : Pole					
Inspector Comment

View of poles on the landside shoulder looking downstream.

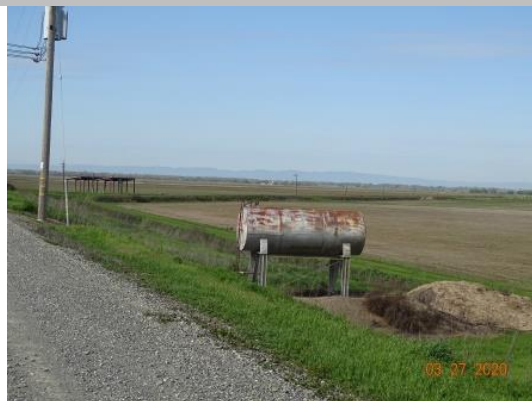
Photo 1 of 1 : SP\_2020\_RD1001\_39\_10\_20200406\_00025.jpg

LM Start	3.81	Rating **	M	Issue No.	10
LM End	3.81	Issue Type +	En	Location *	LS
Category	Earthen Levee			GPS Latitude/Longitude	
				Start	End
Item	Encroachments			38.817178 °	38.817178 °
				-121.552965 °	-121.552965 °
DWR ID	DWR_RD1001_05_s_2012_10				
Comment Code					
TA : Tank					
Inspector Comment					
Fuel tank at landside levee toe.

View of tank on the landside shoulder looking downstream, Spring 2020.

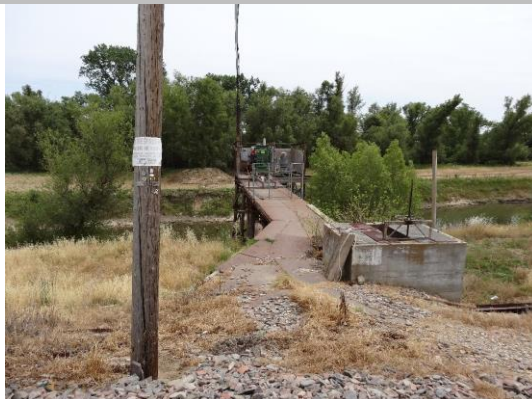
Photo 1 of 3 : UCIP\_SP\_2020\_14486\_23913.jpg

Comment Code						
Inspector Comment						
DS_ID:22604 FS_ID:14486 EP_NO: 1896 Repair Type: Non-Urgent Crossing Status: Found UCIP Comments: 05/15/2013 - slide gate in concrete box on waterside levee toe.- cracked headwall on landside- working during field survey- abandoned steel pipe, may need to remove it or properly abandoned. (P. Amatya - DWR UCIP) FIELD_STRUCT_DESC: *ABANDONED* 1 of 3: 20-inch asbestos bonded corrugated metal irrigation discharge pipe through the levee, 2.13 feet below the crown. Three vertical pumps on a wooden piling structure in the stream. Walkway to the pumps. Slide gate in a concrete box on the waterside (WS). (Permit No. 1896, [permit missing]). [Additional Reference(s): DWR Levee Log, 1993]. FS Date: 5/15/2013

WS- pump station, walkway, and slide gate in concrete box.

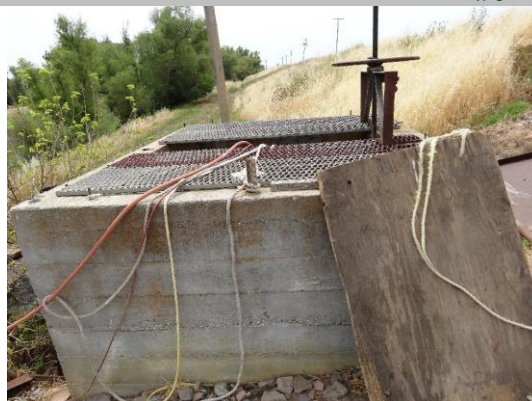
Photo 3 of 3 : UCIP\_SP\_2020\_14486\_23911.jpg

WS- slide gate in concrete box on levee toe.

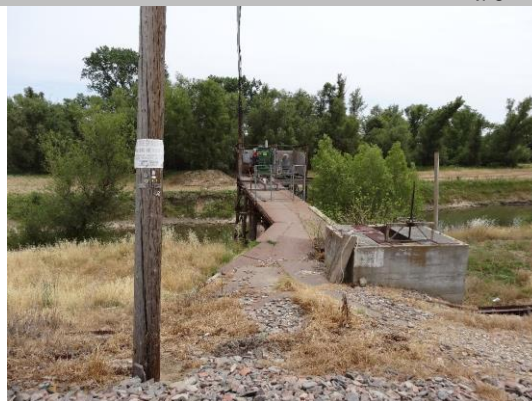
Photo 1 of 3 : UCIP\_SP\_2020\_14484\_23894.jpg

DS\_ID:22595  
 FS\_ID:14484  
 EP\_NO: 1896  
 Repair Type: Non-Urgent  
 Crossing Status: Found  
 UCIP Comments: 05/15/2013 - slide gate in concrete box on waterside levee toe.- cracked headwall on landside- working during field survey (P. Amatya - DWR UCIP)  
 FIELD\_STRUCT\_DESC: \*ABANDONED\* 2 of 3: 20-inch asbestos bonded corrugated metal irrigation discharge pipe through the levee, 2.13 feet below the crown. Three vertical pumps on a wooden piling structure in the stream. Walkway to the pumps. Slide gate in a concrete box on the waterside (WS). (Permit No. 1896, [permit missing]).  
 [Additional Reference(s): DWR Levee Log, 1993].  
 FS Date: 5/15/2013

WS- overview of pump station, walkway, and slide gate in concrete box.

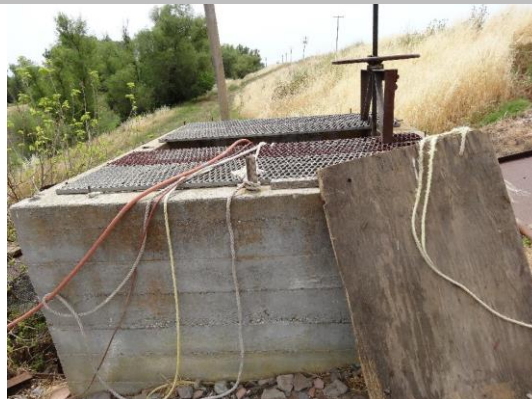
Photo 2 of 3 : UCIP\_SP\_2020\_14484\_23898.jpg

WS- slide gate in concrete box on levee toe.

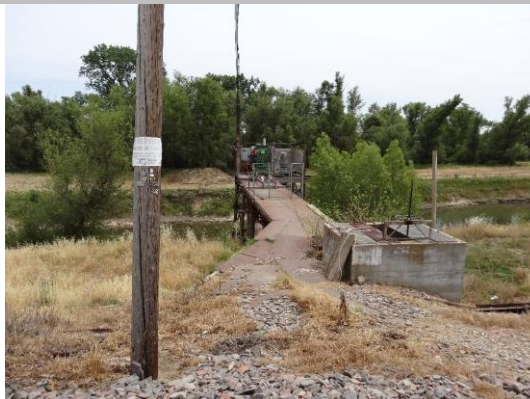
Photo 1 of 3 : UCIP\_SP\_2020\_14472\_23891.jpg

Comment Code						
Inspector Comment						
DS_ID:22613 FS_ID:14472 EP_NO: 1896 Repair Type: Non-Urgent Crossing Status: Found UCIP Comments: 05/15/2013 - slide gate in concrete box on waterside levee toe.- cracked headwall on landside- working during field survey (P. Amatya - DWR UCIP) FIELD_STRUCT_DESC: *ABANDONED* 3 of 3: 30-inch asbestos bonded corrugated metal irrigation discharge pipe through the levee, 2.13 feet below the crown. Three vertical pumps on a wooden piling structure in the stream. Walkway to the pumps. Slide gate in a concrete box on the waterside (WS). (Permit No. 1896, [permit missing]). [Additional Reference(s): DWR Levee Log, 1993]. FS Date: 5/15/2013

WS- pump station, walkway, and slide gate in concrete box on levee toe

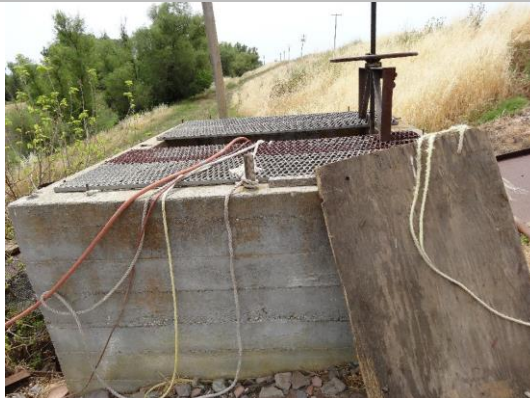
Photo 2 of 3 : UCIP\_SP\_2020\_14472\_23890.jpg

WS- slide gate in concrete box on levee toe

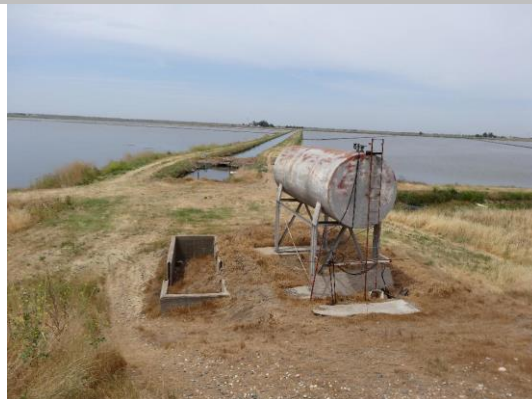
Photo 3 of 3 : UCIP\_SP\_2020\_14472\_23889.jpg

LS- pipes discharge water in irrigation ditch on landside (top)

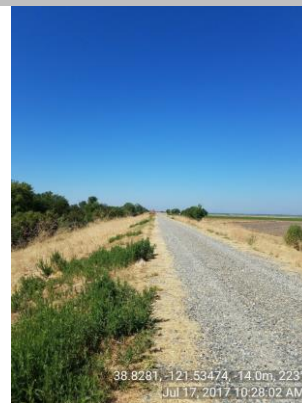
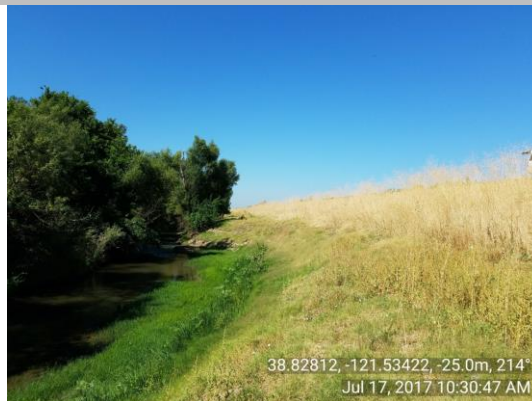
Photo 1 of 3 : LEVAL\_SP\_2020\_493\_1759.jpg

LM Start	5.05	Rating **	M	Issue No.	8
LM End	5.06	Issue Type +	Ma	Location *	WS
Category	Earthen Levee			GPS Latitude/Longitude	
				Start	End
Item	Erosion / Bank Caving			38.828100 °	38.828188 °
				-121.534740 °	-121.534625 °
DWR ID	RD 1001-03				
Comment Code					
E2 : Schedule repair of erosion site prior to the next inspection.					
Inspector Comment					
This was a 2017 Storm Damage Site.					
Site ID No:493					
Site Designation:RD 1001-03

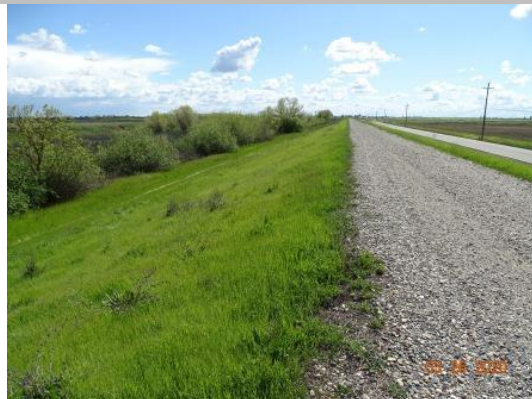
Photo 1 of 1 : SP\_2020\_RD1001\_40\_25\_20200406\_00054.jpg

LM Start	0.01	Rating **	A	Issue No.	25
LM End	4.73	Issue Type +	Ma	Location *	WS
Category	Earthen Levee			GPS Latitude/Longitude	
				Start	End
Item	Vegetation			38.831197 °	38.896350 °
				-121.529559 °	-121.520369 °
DWR ID	DWR_RD1001_06_s _ 2020_25				
Comment Code					
V1 : Control annual grass and weeds on the levee slopes and easements.					
Inspector Comment					
The annual vegetation is well maintained, Spring 2020.

View looking downstream waterside at the well maintained annual vegetation, Spring 2020.

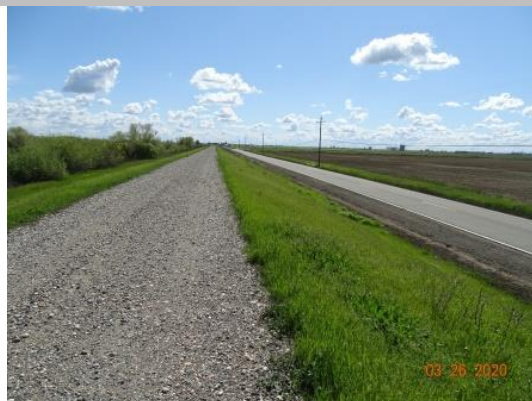
Photo 1 of 1 : SP\_2020\_RD1001\_40\_23\_20200406\_00053.jpg

LM Start	0.01	Rating **	A	Issue No.	23
LM End	4.73	Issue Type +	Ma	Location *	LS
Category	Earthen Levee			GPS Latitude/Longitude	
				Start	End
Item	Vegetation			38.831197 °	38.896350 °
				-121.529558 °	-121.520369 °
DWR ID	DWR_RD1001_06_s _ 2020_23				
Comment Code					
V1 : Control annual grass and weeds on the levee slopes and easements.					
Inspector Comment					
The annual vegetation is well maintained, Spring 2020.

View looking downstream landside at the well maintained annual vegetation, Spring 2020.

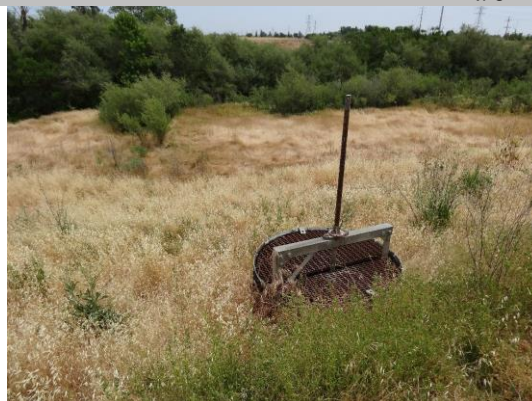
Photo 1 of 3 : UCIP\_SP\_2020\_55186\_23508.jpg

Comment Code					
Inspector Comment					
DS_ID:22636 FS_ID:55186 EP_NO: N/A Repair Type: Non-Urgent Crossing Status: Found UCIP Comments: 08/21/2019 Record has been updated from No Action Needed to Non-Urgent due to limited inspection on the LS and missing permit authorizing crossing. Record updated with USACE O&M reference. Dense vegetation prevented a thorough inspection of the levee slopes. Pipe is selected for DMP internal video inspection. A good evaluation of pipe condition will be available once the DMP internal video inspection is completed. (O. Magana - DWR UCIP)05/15/2013 - steep levee slope- dense vegetation (P. Amatya - DWR UCIP) FIELD_STRUCT_DESC: 36-inch corrugated metal gravity drainage pipe through the levee, 17.6 feet below the crown. Slide gate in a 48-inch corrugated metal pipe (CMP) riser on the waterside (WS) slope. Concrete U-shaped headwall at the landside (LS) toe. Pipe crosses under the channel. [Additional Reference(s): DWR Levee Log, 1993. USACE Sacramento O&M Manual, Unit 142 - Back Levee of Reclamation District No. 1001, June 1959, Revised 04 May 2018, 36-inch pipe (HLM 0.03)]. FS Date: 8/21/2019 12:52:00 PM

WS- slide gate, air vent in CMP riser.

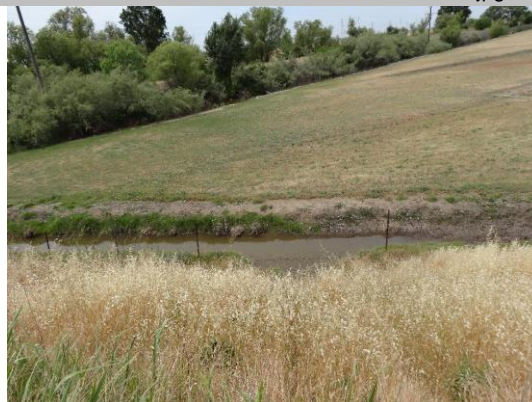
Photo 2 of 3 : UCIP\_SP\_2020\_55186\_23507.jpg

LS- pipe discharges into irrigation ditch

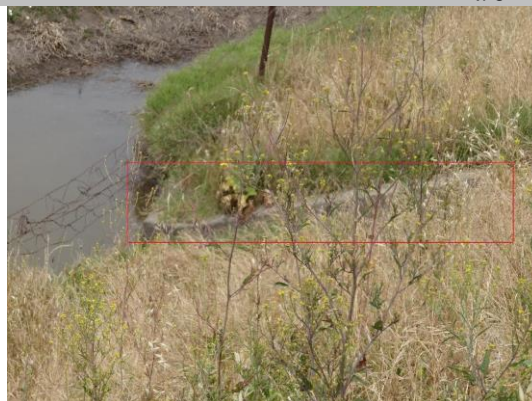
Photo 3 of 3 : UCIP\_SP\_2020\_55186\_23506.jpg

LS-concrete wing/head wall on levee toe.

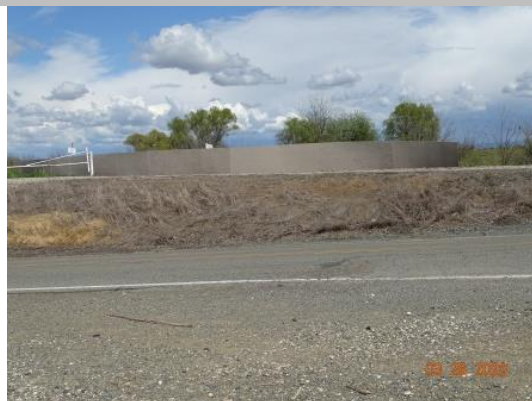
Photo 1 of 1 : SP\_2020\_RD1001\_40\_16\_20200406\_00055.jpg

LM Start	0.47	Rating **	U	Issue No.	16
LM End	0.47	Issue Type +	En	Location *	CR
Category	Earthen Levee			GPS Latitude/Longitude	
				Start	End
Item	Encroachments			38.837366 °	38.837366 °
				-121.526579 °	-121.526579 °
DWR ID	DWR_RD1001_06_f _ 2018_16				
Comment Code					
FE : Fence					
Inspector Comment					
The solid fence needs to be removed from the crown, Spring 2020.

View looking at waterside crown at an unpermitted solid fence, Spring 2020.

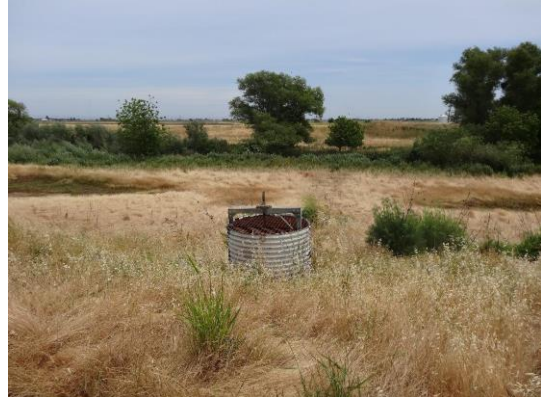
Photo 1 of 3 : UCIP\_SP\_2020\_55187\_23510.jpg

Comment Code						
Inspector Comment						
DS_ID:22635 FS_ID:55187 EP_NO: N/A Repair Type: Non-Urgent Crossing Status: Found UCIP Comments: 08/21/2019 Record has been updated from No Action Needed to Non-Urgent, no permit has been issued authorizing crossing. Record updated with USACE O&M reference. A good evaluation of pipe condition will be available once the DMP internal video inspection is completed. (O. Magana - DWR UCIP) FIELD_STRUCT_DESC: 36-inch corrugated metal gravity drainage pipe through the levee, 14.3 feet below the crown. Slide gate in a 48-inch corrugated metal pipe (CMP) riser on the waterside (WS) slope. Concrete headwall at the landside (LS) toe. Pipe crosses under the channel. [Additional Reference(s): DWR Levee Log, 1993. USACE Sacramento O&M Manual, Unit 142 - Back Levee of Reclamation District No. 1001, June 1959, Revised 04 May 2018, 36-inch pipe (HLM 0.56)]. FS Date: 8/21/2019 12:52:00 PM

WS- slide gate in CMP riser on levee slope

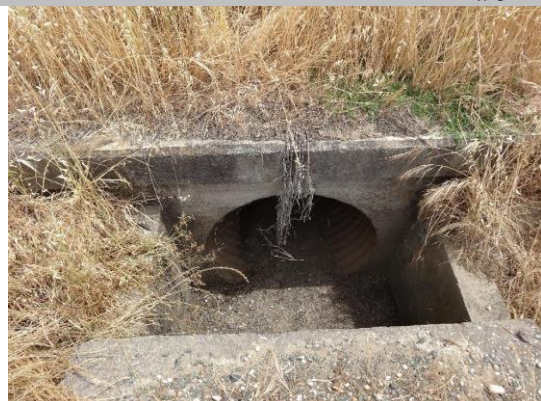
Photo 2 of 3 : UCIP\_SP\_2020\_55187\_23509.jpg

LS- concrete distribution box with headwall on levee toe.

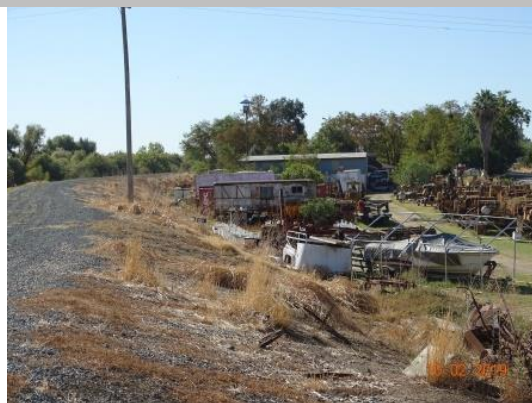
Photo 1 of 1 : SP\_2020\_RD1001\_40\_3\_20200227\_00001.jpg

LM Start	1.45	Rating **	M	Issue No.	3
LM End	1.53	Issue Type +	En	Location *	LS
Category	Earthen Levee			GPS Latitude/Longitude	
				Start	End
Item	Encroachments			38.851234 °	38.852445 °
				-121.524421 °	-121.524809 °
DWR ID	DWR_RD1001_06_s_2012_3				
Comment Code					
EQ : Equipment					
Inspector Comment					
Remove equipment from levee toe, Spring 2020.

View looking downstream of the equipment at the landside levee toe.

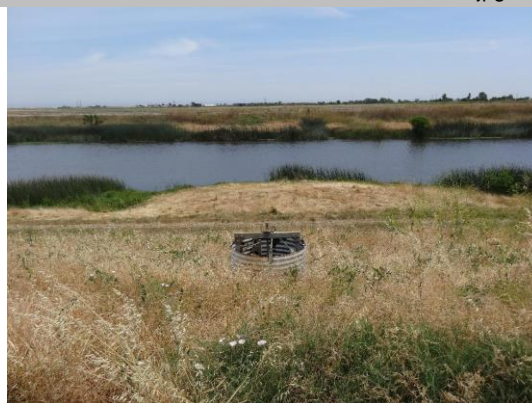
Photo 1 of 3 : UCIP\_SP\_2020\_55199\_23467.jpg

LM Start	1.72	Rating **	U	Issue No.	49	
LM End	1.72	Issue Type +	En	Location *		
Category	Supplemental			GPS Latitude/Longitude		
				Start	End	
Item	DWR UCIP Field Study			38.855186 °	38.855186 °	
				-121.524895 °	-121.524895 °	
DWR ID	22617

Comment Code						
Inspector Comment						
DS_ID:22617 FS_ID:55199 EP_NO: N/A Repair Type: Urgent Crossing Status: Found UCIP Comments: 08/21/2019 Pipe has been upgraded to Urgent: Pipe Integrity due to deteriorated pipe section at inlet. DMP internal video inspection still hasn't been completed to determine extent of damage through levee. Record updated with USACE O&M reference. (O. Magana - DWR UCIP)05/15/2013 - visible damage to pipe on opening at inlet due to high corrosion.- video inspection recommended. (P. Amatya - DWR UCIP) FIELD_STRUCT_DESC: 36-inch corrugated metal gravity drainage pipe through the levee, 12.5 feet below the crown. Slide gate in a 48-inch corrugated metal pipe (CMP) riser on the waterside (WS) slope. Concrete headwall at the landside (LS) toe. Pipe crosses under the channel. [Additional Reference(s): DWR Levee Log, 1993. USACE Sacramento O&M Manual, Unit 142 - Back Levee of Reclamation District No. 1001, June 1959, Revised 04 May 2018, 30-inch pipe (HLM 1.72)]. FS Date: 8/21/2019 12:53:00 PM

WS- slide gate in CMP riser on levee slope.

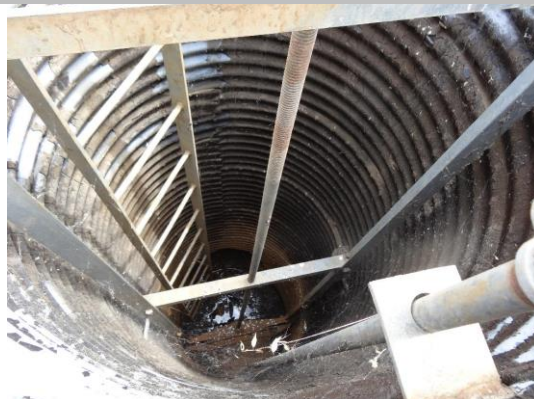
Photo 2 of 3 : UCIP\_SP\_2020\_55199\_23466.jpg

WS- slide gate, air vent pipe in CMP riser on levee slope.

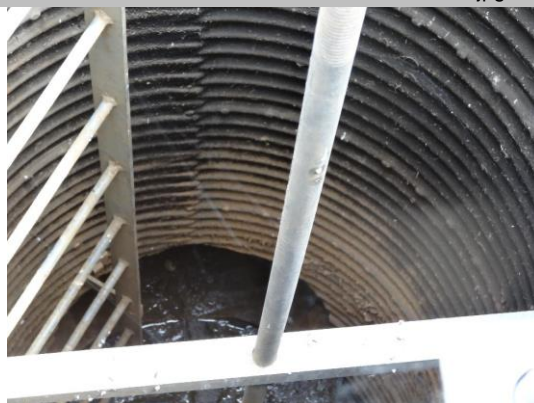
Photo 3 of 3 : UCIP\_SP\_2020\_55199\_23465.jpg

WS- pipe opening visible inside CMP riser.

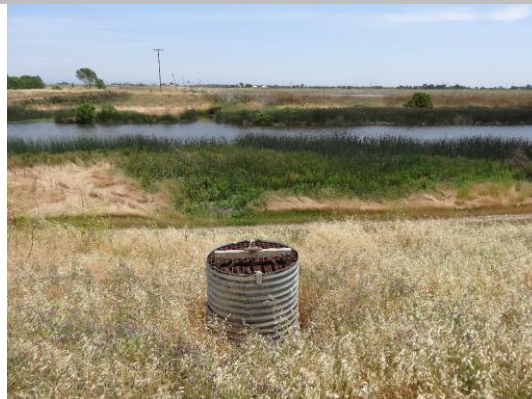
Photo 1 of 3 : UCIP\_SP\_2020\_55196\_23445.jpg

DS\_ID:22616  
FS\_ID:55196  
EP\_NO: N/A  
Repair Type: Non-Urgent  
Crossing Status: Found  
UCIP Comments: 08/21/2019 Record remains Non-Urgent due to missing permit authorizing crossing and limited inspection on the LS. Dense vegetation prevented a thorough inspection of levee section at pipe location. Record updated with USACE O&M reference. (O. Magana - DWR UCIP)05/15/2013 - pipe buried/submerged on LS- needs cleaning of LS pipe end opening. (P. Amatya - DWR UCIP) FIELD\_STRUCT\_DESC: 24-inch corrugated metal gravity drainage pipe through the levee, 15.5 feet below the crown. Slide gate in a 36-inch corrugated metal pipe (CMP) riser on the waterside (WS) slope. Concrete headwall at the landside (LS) toe. Pipe crosses under the channel. [Additional Reference(s): DWR Levee Log, 1993. USACE Sacramento O&M Manual, Unit 142 - Back Levee of Reclamation District No. 1001, June 1959, Revised 04 May 2018, 24-inch pipe (HLM 2.03)].

WS- slide gate in CMP riser on levee slope.

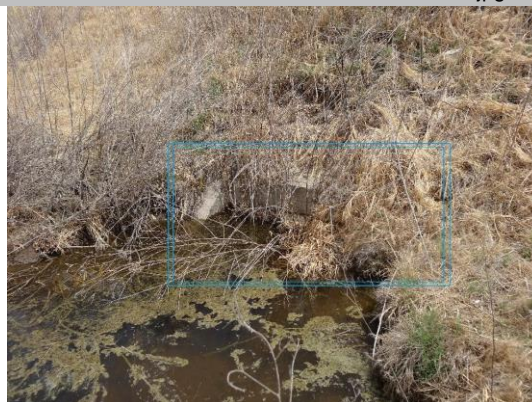
Photo 2 of 3 : UCIP\_SP\_2020\_55196\_23444.jpg

LS- concrete wing wall on levee toe

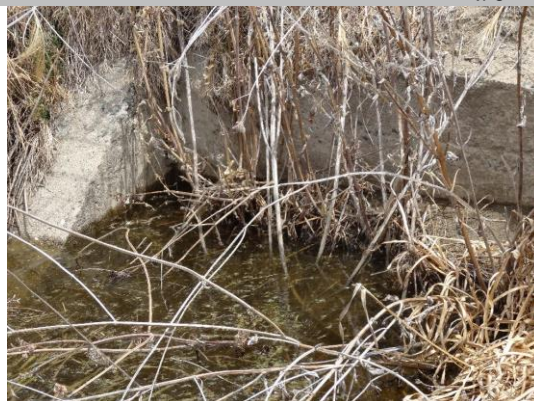
Photo 3 of 3 : UCIP\_SP\_2020\_55196\_23443.jpg

LS- pipe submerged/buried in concrete wing wall on levee toe
